Dangerous highways – a motorcyclist and bicyclist update

Posted on 23 September, 2021 by | [John Platts-Mills](#)

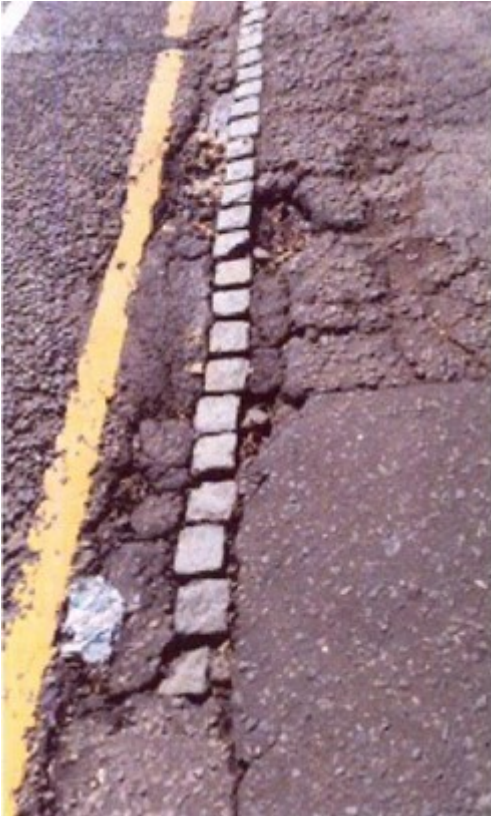
Whilst exiting a petrol station the claimant lost control of her motorbike and collided with a car. The claimant’s injuries were feared to be life-threatening: she had bleeding to her brain as well as a severely broken right arm, broken left arm, broken left leg and collapsed lung. Following the accident, the claimant’s children sent the highway authority photographs of a pothole said to have caused the claimant to lose control:

The highway authority immediately carried out temporary repairs, with more permanent repairs following in 2017 and 2018. The parties' experts agreed that the pothole was about 200mm wide, 200-300mm long and 40-50mm deep.

The claimant had no recollection of the accident, and her case that the loss of grip was attributable to a defect in the road depended upon the evidence of a member of her club. The court found his evidence unreliable, noting his failure to raise the pothole with the police at the scene or the local authority after the event. Accordingly, the claim failed for want of causation.

The court proceeded to consider the issue of dangerousness in any event. In concluding that the pothole was not dangerous, the court addressed the claimant's use of the highway and the characteristics of use by motorcyclists generally.

It reasoned that whilst motorcycles are more vulnerable to defects than motorcars, they also have a greater choice as to which part of the road to use. The court distinguished between the defect in issue, which in the court's view could be easily avoided and a defect in the middle of a carriageway, which a motorcyclist might encounter unexpectedly and

when travelling at speed.
