Dangerous highways – a motorcyclist and bicyclist update

Posted on 23 September, 2021 by | [John Platts-Mills](#)

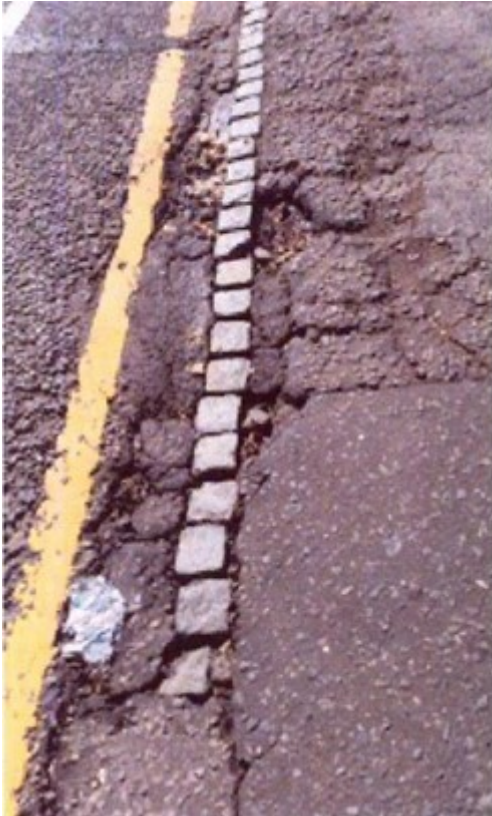
Whilst exiting a petrol station the claimant lost control of her motorbike and collided with a car. The claimant’s injuries were feared to be life-threatening: she had bleeding to her brain as well as a severely broken right arm, broken left arm, broken left leg and collapsed lung. Following the accident, the claimant’s children sent the highway authority photographs of a pothole said to have caused the claimant to lose control:

The highway authority immediately carried out temporary repairs, with more permanent repairs following in 2017 and 2018. The parties' experts agreed that the pothole was about 200mm wide, 200-300mm long and 40-50mm deep.

It reasoned that whilst motorcycles are more vulnerable to defects than motorcars, they also have a greater choice as to which part of the road to use. The court distinguished between the defect in issue, which in the court's view could be easily avoided and a defect in the middle of a carriageway, which a motorcyclist might encounter unexpectedly and
